NASA-CR-72713
WANL-PR-(RRR)-001

**EVALUATION OF MECHANICAL PROPERTIES,
OXIDATION RESISTANCE, AND STRUCTURE OF
SLURRY SILICIDE COATED T-222**

Westinghouse Astronuclear Laboratory

December 19, 1969

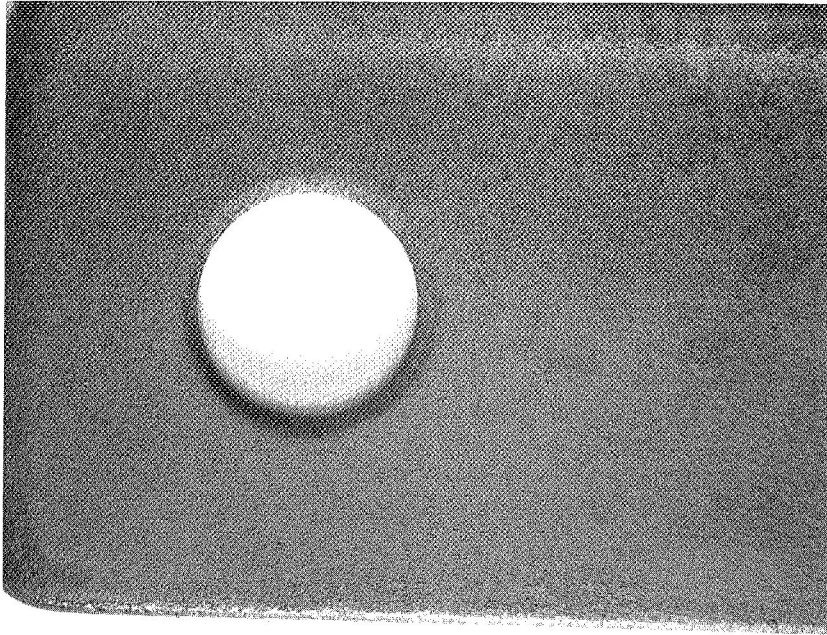
Oxidation testing at 2400° F was approached cautiously due to an anticipated problem of sample handling, and only one sample, arbitrarily chosen to be tensile 28, was used in an initial two hour test. Unaided visual inspection of this sample after 2 hour exposure at 2400° F revealed a coating crack located approximately 1/2 inch below a pin hole. Oxidation of the substrate at the defective site, however, was not evident.

A photograph showing the crack is presented in Figure 7A. As a consequence of this, close examination was made of the coating on the other samples scheduled for oxidation revealing, with assistance of 5X magnification, fine hairline cracks on tensile samples 29, 30 and 31, at a location similar to that observed cracked on tensile 28. Photographs of two of these samples displaying the defects are presented in Figure 8. Three tensile samples, numbers 12, 13 and 33, inspected and found to be free of any macroscopically obvious coating cracks, were substituted for specimens 29, 30 and 31. Oxidation was continued, however, on tensile 28. Sample handling did not pose any problem on the initial two hour test using tensile 28, and subsequent tests were performed simultaneously on all samples.

FIGURE 7 - Progress of Coating Failure on Tensile Sample 28

FIGURE 7 (Continued) - Progress of Coating Failure on Tensile Sample 28

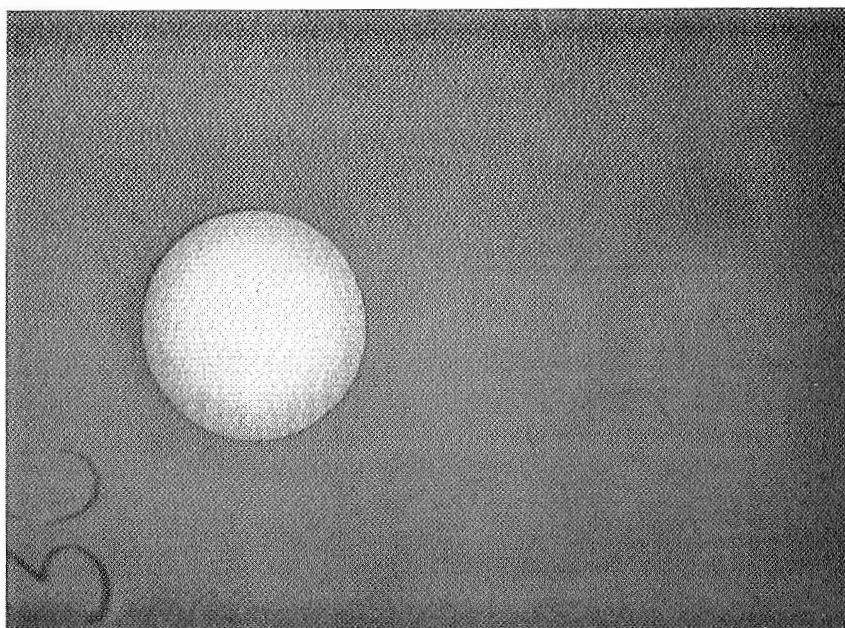
FIGURE 8 - Typical Cracking Found on As-Coated Tensile Samples

above this feature on the other. Because of this, whether the crack found on tensile 28 was present in the as-coated condition or occurred during exposure, cannot be established. Substrate oxidation was not evident at the defective sites on any of these samples, as was observed on tensile 28.

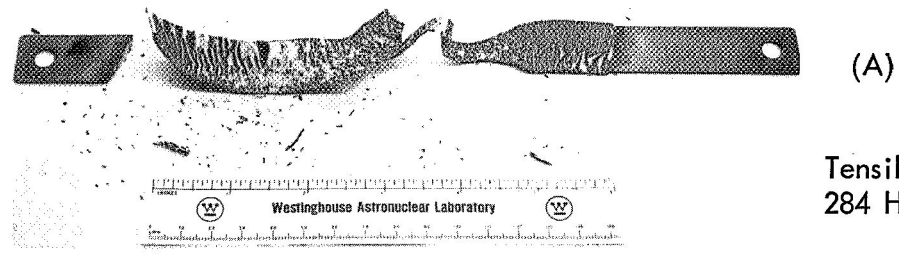
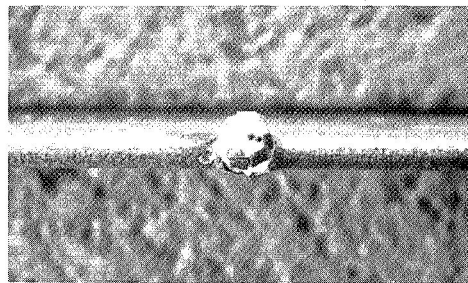
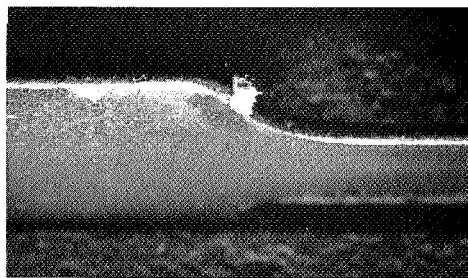
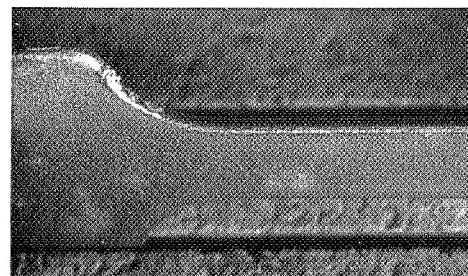
Coating failure on bend 17 could not be attributed to any defect caused by contact with the silicon carbide brick used to hold the specimen, since it occurred on the edge opposite that held in the support slot. In this regard, none of the oxidation failures observed on tensile samples could be related to contact with the SiC brick, since those developed at edge positions were located within a gauge section radius (Nos. 16 and 33), while the four flat surface failures occurred well above the brickline (Nos. 12, 13, 18, 28).

FIGURE 11 - Coating Failure on Tensile Samples 16, 17 and 33, and Bend Sample 17

A possible cause for substrate oxidation on tensiles 16 and 33 might be a thin coating at the failure sites. Both samples developed failures at edge sites within a gauge section radius, at a position close to the corner formed by the head section and the radius — Figures 11C & D. The failures, therefore, occurred on an edge nearly perpendicular to the specimen axis. If the metallic coating constituents applied prior to pack siliciding were sprayed on with the jet kept reasonably perpendicular to the axis of the sample, these regions on each gauge section radius would be least covered, and sites vulnerable to failure. The grip pin holes in the tensile sample would likewise be areas susceptible to application of a thin silicide coat. Coating failure, however, was not experienced within even one pin hole on any tensile sample. Perhaps, because the holes are obviously vulnerable in this respect, greater attention was paid them, to insure they were adequately coated. Whether or not the suggestion offered as a possible explanation for oxidation failure on tensiles 16 and 33 is correct, any edge site, because of its shape, is intuitively a region of high defect probability.

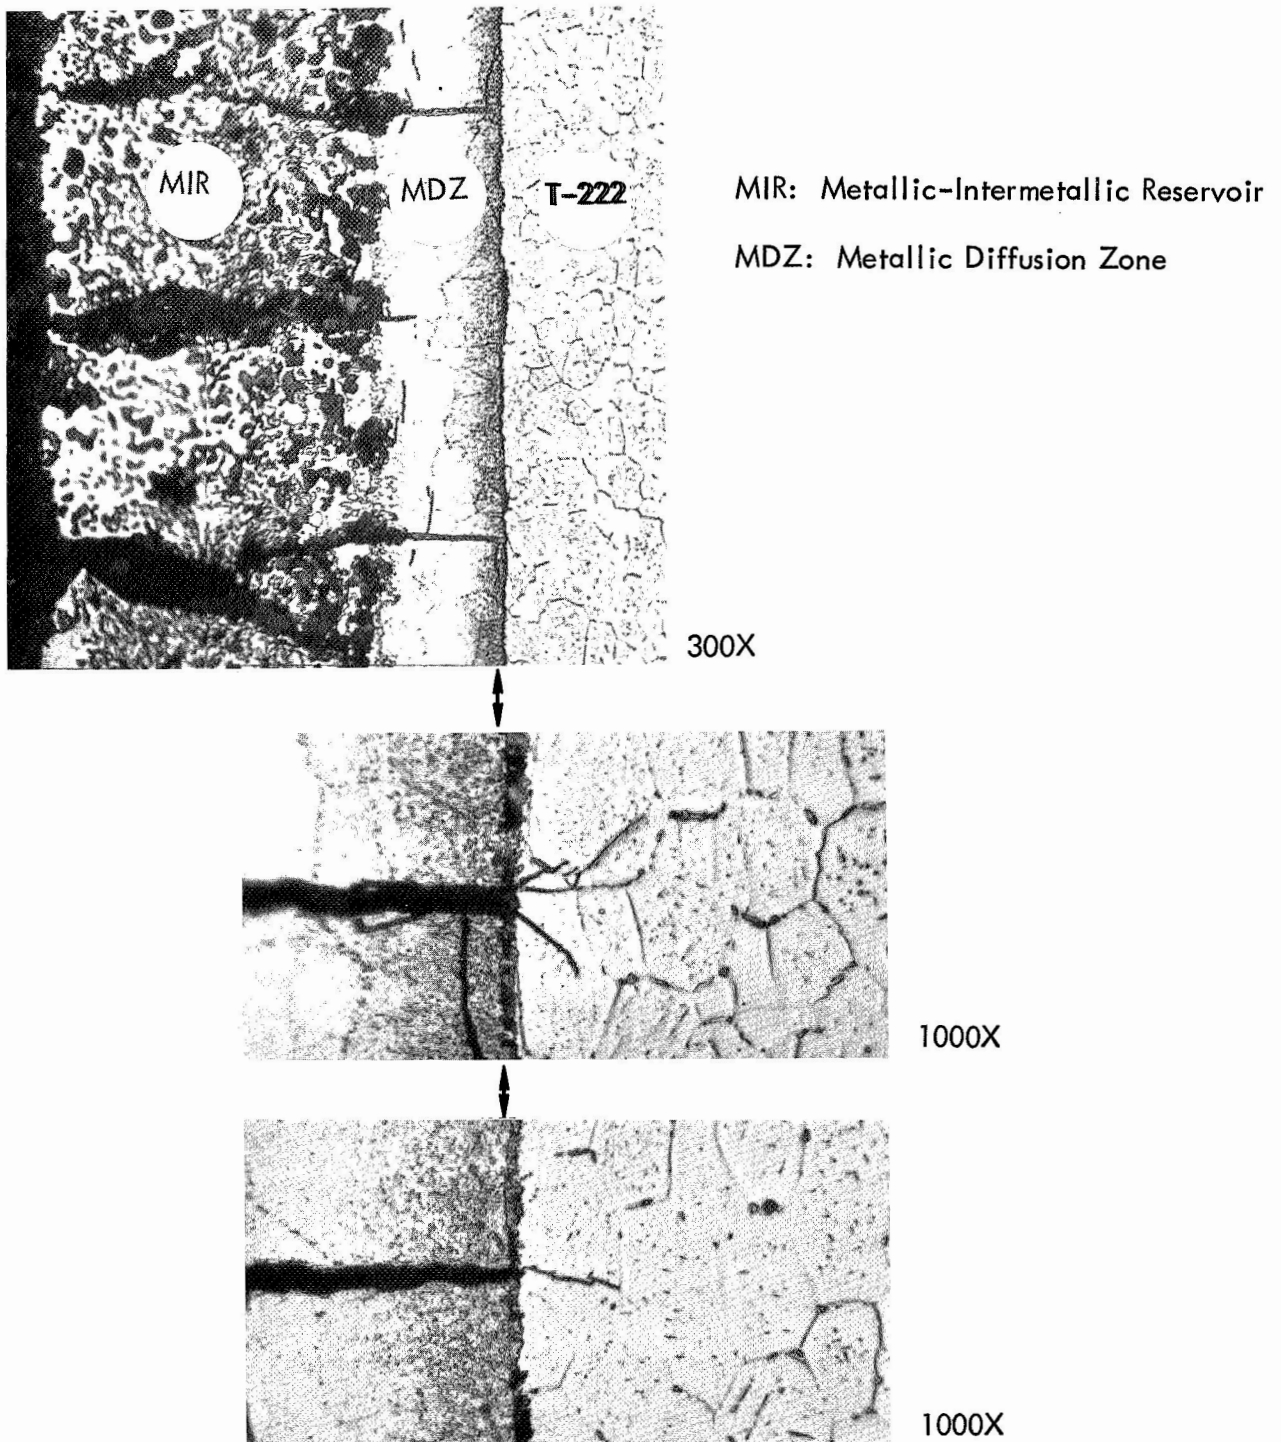
FIGURE 24 - Oxide Formation on Creep Sample 27

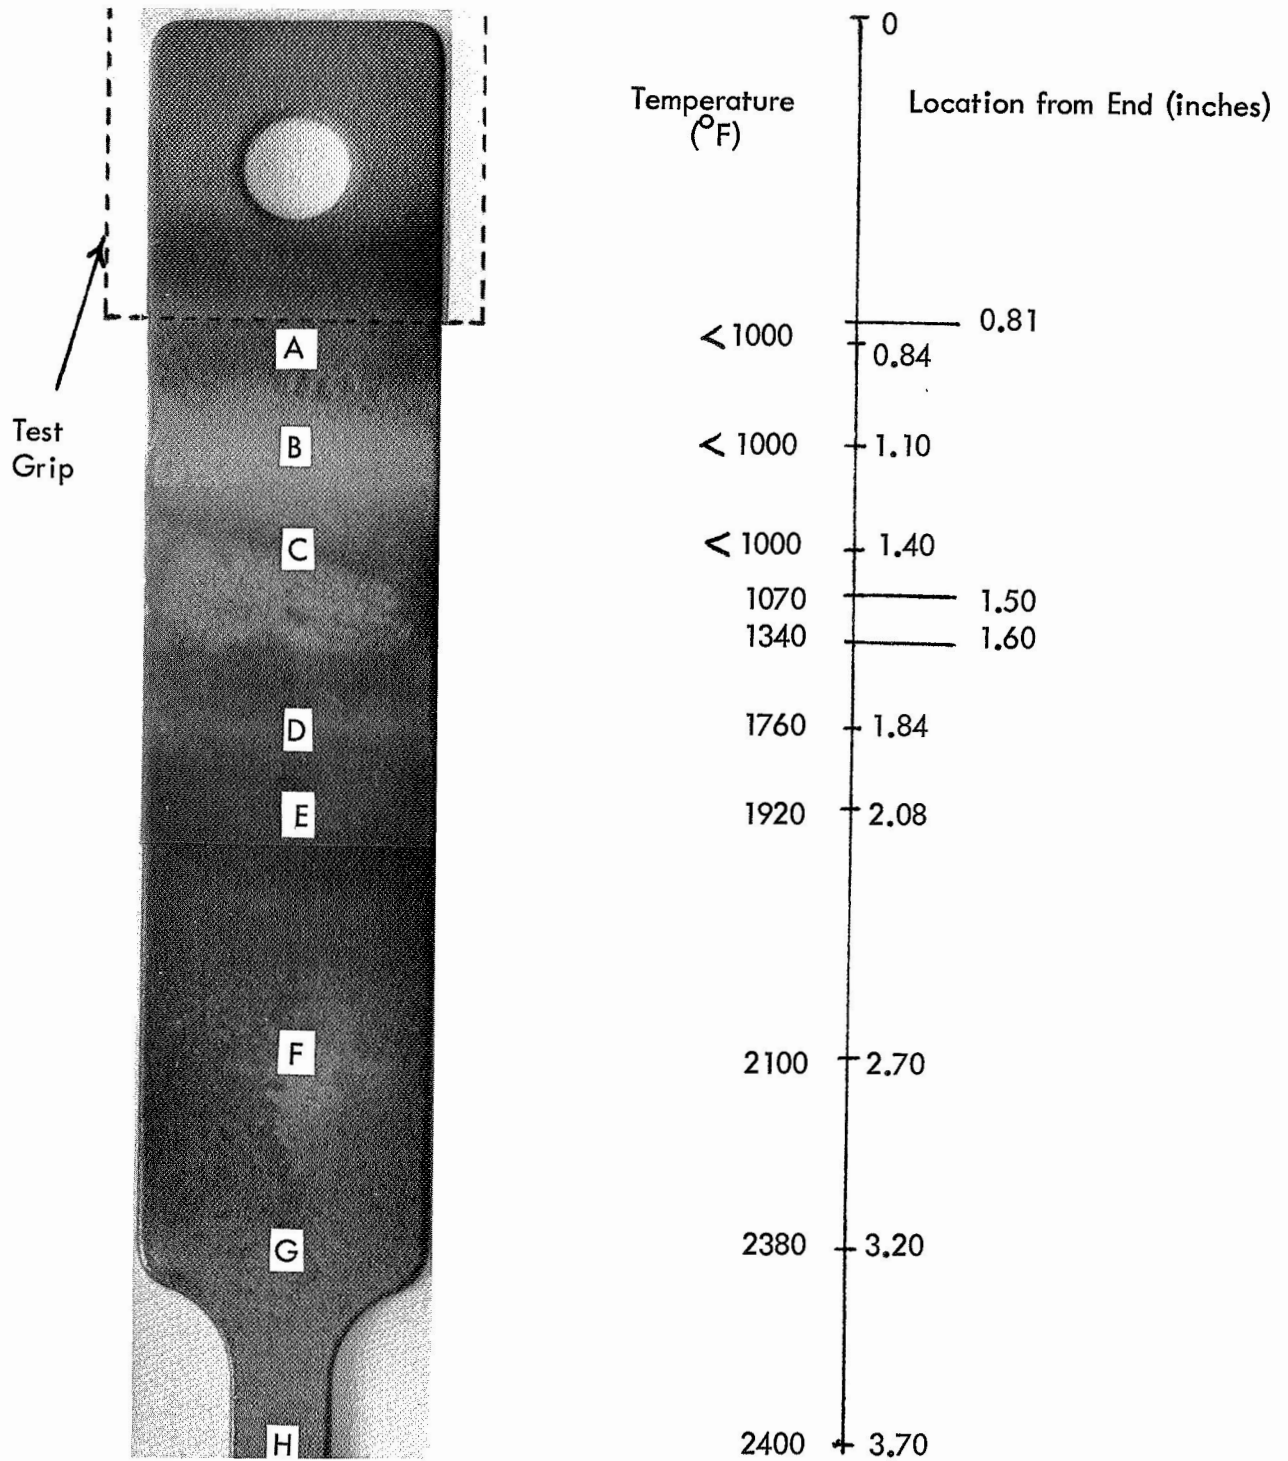
FIGURE 39 - Temperature Distribution and Surface Appearance Along Creep Sample 38. Air Test 500 Hours/2400°F
